ATTACHMENT 17

SHORING DRAIN DETAIL

12348 Redmond - Woodinville Road N.E. Redmond, Washington

Job No:	Date:	Plate:
15538	Jan. 2016

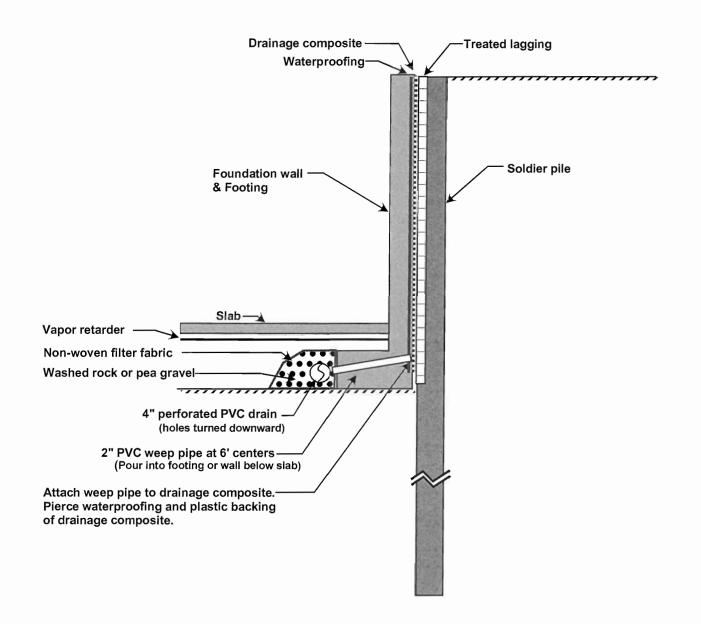
Note - Refer to the report for additional considerations related to drainage and waterproofing.
